## Duct Sealing Performed For:

Customer: [REDACTED] Waldorf, MD 20601	AEROSEAL CASE ID: [REDACTED]
DATE: 9/10/2021	SYSTEM DESCRIPTION: gas furnace
	SEAL DESCRIPTION: supply/return
	HARDWARE: HomeSeal Connect
	TECHNICIAN: Chris Mckenzie

## Overall Sealing Results:

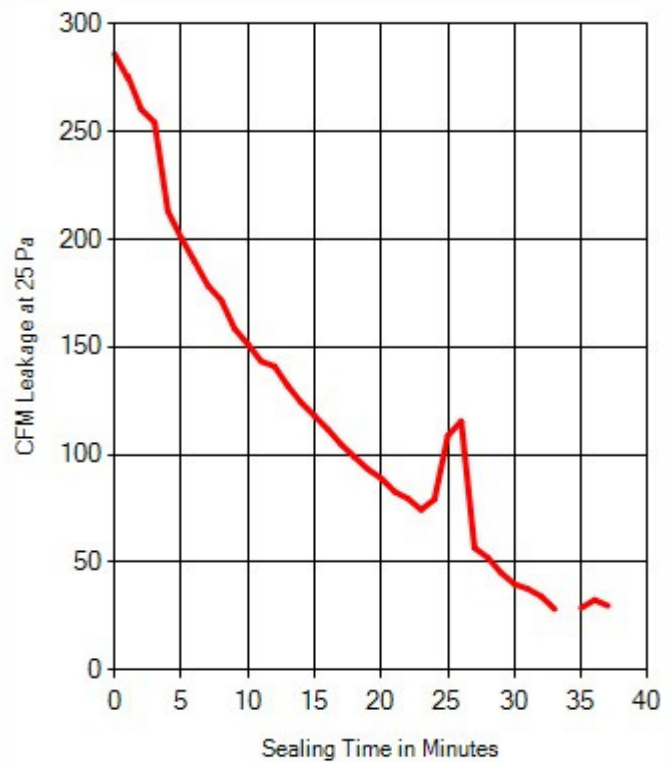
## AeroSeal Sealing Progress:

286.1 CFM of Leakage, equivalent to a  
54.1 Square Inch Hole or  
24% of the system capacity of 1200.0 CFM

29.8 CFM of Leakage, equivalent to a  
5.6 Square Inch Hole or  
2.5% of system capacity

**This corresponds to a  
90% Reduction in  
Duct Leakage**
